ARMY ENGINEER WATERWAYS EXPERIMENT STATION VICKSBURG MS F/G 6/6
THE WHITE AMUR AS A BIOLOGICAL CONTROL AGENT OF AQUATIC WEEDS I--ETC(U)
APR 79 P E CUSTER, F D HALVERSON, J M MALONE

4. TITLE (and Subtitle) THE WHITE AMUR AS A BIOLOGICAL CONTROL AGENT OF AQUATIC WEEDS IN THE PANAMA CANAL		5. TYPE OF REPORT & PERIOD COVERED Final report

THE WHITE AMUR AS A BIOLOGICAL CONTROL AGENT
OF AQUATIC WEEDS IN THE PANAMA CANAL

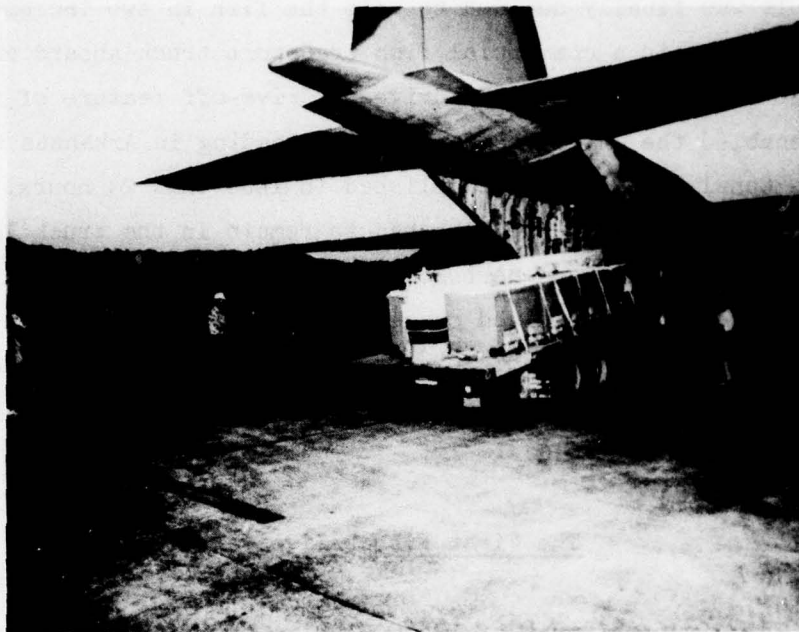
Figure 2. Unloading the fish transport truck from the Air Force C-130 at Howard Air Force Base, Canal Zone

16. The first shipment of 125,000 white amur fingerlings was made on 13 February 1978. The fish transport truck was driven from Lonoke, Ark., to Little Rock Air Force Base, then loaded on board the C-130 aircraft and flown to Howard Air Force Base in the Canal Zone (Figure 2). After the fish arrived, the truck was driven to Calamito Lake, the second largest of the three grow-out ponds, and the acclimation period was started in the transport tanks by mixing lake water at 28°C with the water in the tanks at 2°C (Figure 3). The transport truck had 16 tanks, each with a 380-litre capacity. The tanks had D.O. levels in excess of 10 mg/l, while lake conditions varied between 3 and 5 mg/l depending on location and depth.

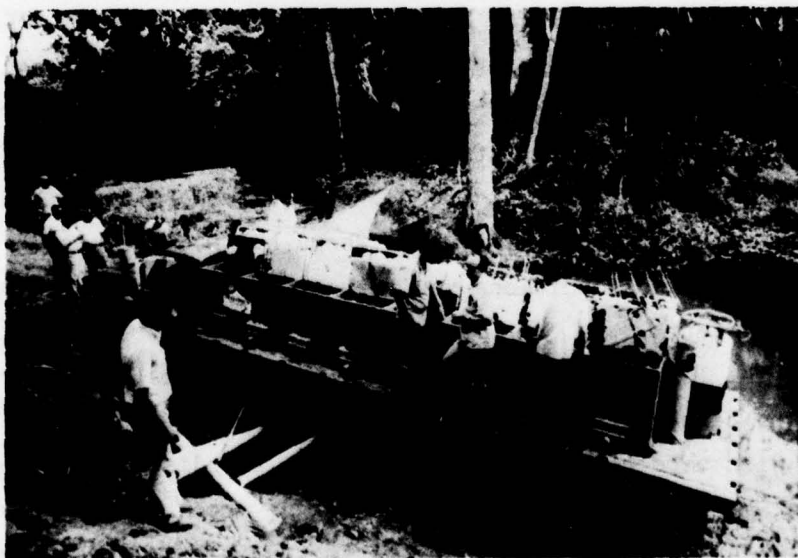
Figure 3. Temperature tempering at the edge of Lake Calamito with the first shipment of fish. This method proved to be unsuccessful because the temperature rise could not accurately be controlled and the fish could not be left in the truck long enough

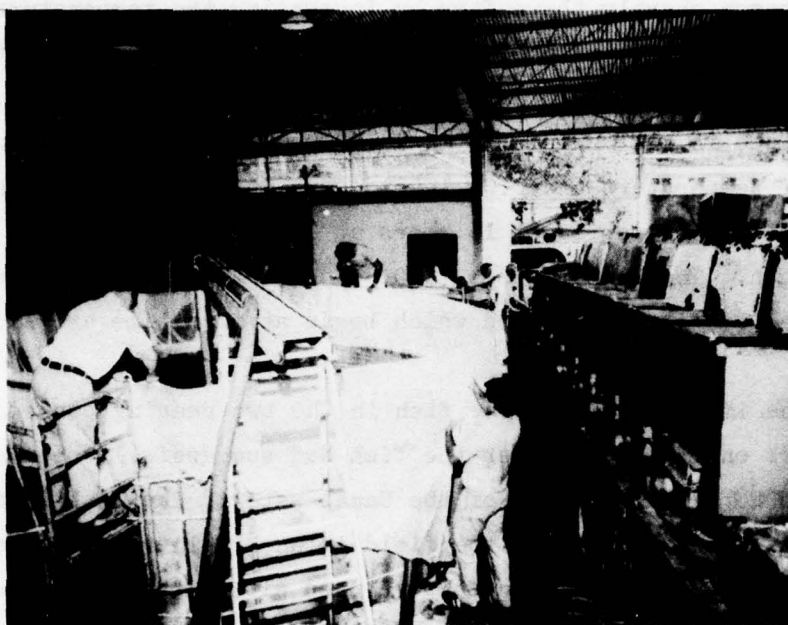
Figure 4. Fish holding tank constructed at Paraiso, Canal Zone, for the second shipment of fish. Transport truck is parked beside tank ready to be unloaded

30. The aircraft arrived at Howard Air Force Base in the Canal Zone in the early morning hours of 13 March. After deplaning and administrative formalities, the truck was driven to the acclimation facility at Paraiso, a distance of about 20 km (Figure 4).

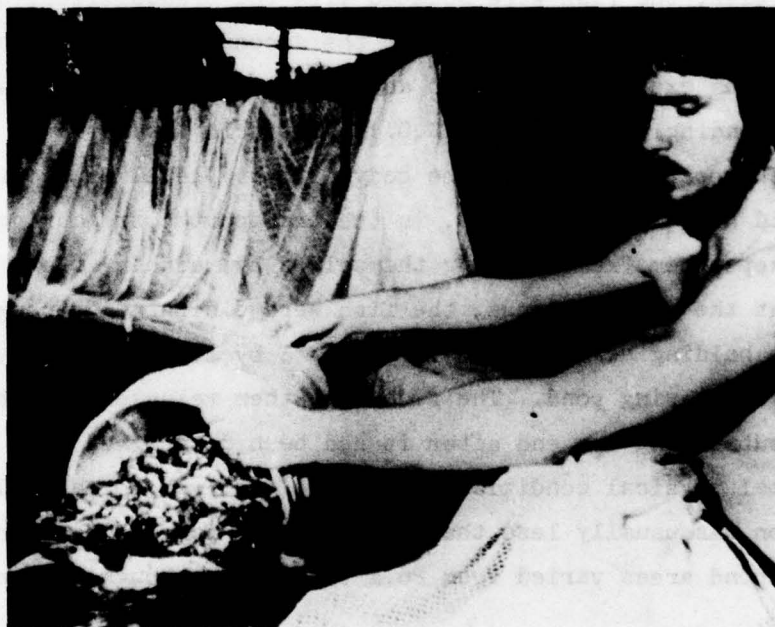
Figure 5. Transferring fingerlings of the second shipment from the truck to the fish holding tank

31. The transfer of fish from the truck to the holding tank (Figure 5) began when temperatures in both had equalized to 14.4°C. All

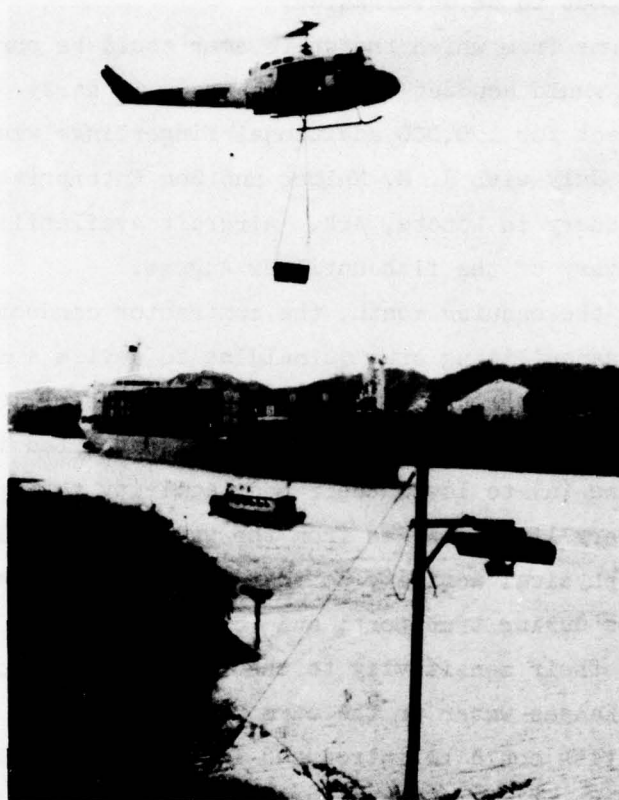
Figure 6. Aerial transport of the fish from the acclimation facility to the grow-out ponds

32. The implantation of the fish in the two rearing ponds began at 0800 hours on 15 March, after the fish had successfully been acclimated to the $28^{\circ}\text{C}+$ temperature of the Canal water. The fish were netted out of the tank and carried to the field in an 850-litre fiberglass air-transportable fish box. Two boxes were used alternately and were moved from the holding tank to a helicopter pickup site 0.5 km away on a flatbed truck. They were then transported to the rearing ponds slung beneath a U. S. Army helicopter in eight sorties (Figure 6). In the last six sorties, the fish were sedated with the tranquilizer, quinaldine. The sedative was employed after the second sortie in which a 20 percent loss was experienced due to an increase in water temperature which correspondingly lowered the D.O. level during transport. The quinaldine successfully reduced the body activity level of the fish such that they did not deplete the D.O. in the transport boxes during the flight and kept them from injuring themselves by reducing their physical activity. At the rearing ponds, the fish were discharged through PVC pipes into a holding screen enclosure (3 by 3 by 1.5 m) which was floated in the rearing pond. The fish were then released from the enclosure by submerging one end after it had been determined that they were in normal physical condition. The time required to make such a determination was usually less than 20 minutes. Lake temperatures in the rearing pond areas varied from 26.1 to 28.3°C throughout the day of implantation.

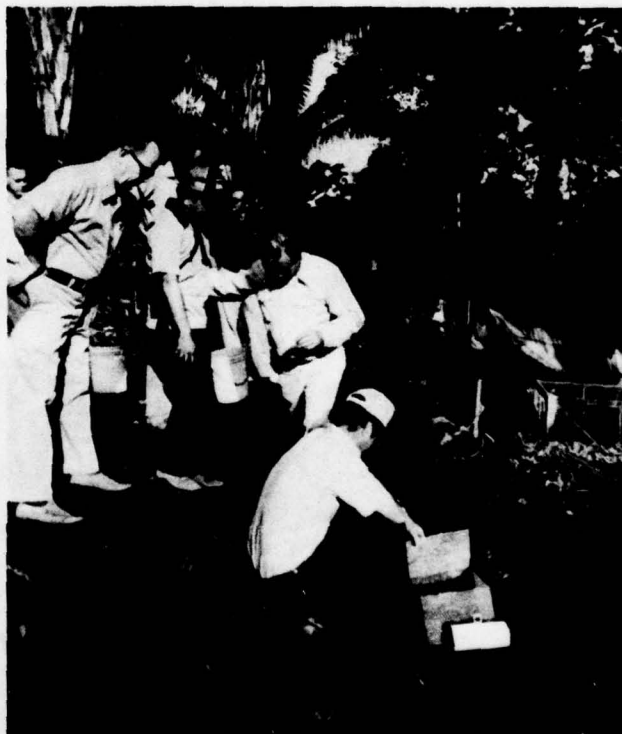
Figure 7. Fish from the third shipment being placed in a 1-ft³ screened cage and observed

test the ability of the fish to make the transition from the transport truck water at 21°C to the lake water of 28°C, approximately 30 fish were placed in a 1-ft³ wire enclosure in the lake and observed for more than half an hour (Figure 7). As the effect of the quinaldine wore off, the fish became more active but demonstrated no temperature shock. The fish were "shot" down a 4-in.-diam pipe from the truck into a 3- by 3- by 1.5-m screened enclosure which was floated in the lake (Figure 8). Discharging the fish into this enclosure enabled a determination to be made that the fish were well prior to their release into the lake. Three such enclosures were used, each containing about 60,000 fish. As each enclosure was filled, it was towed out to a raft in the middle of the lake (Figure 9) and another brought up to the bank to be filled. After approximately 45 minutes, it was decided that the fish were completely acclimated to their new environment, and the cages were tipped up on end and the fish "herded" out into the lake. Less than 100 fish

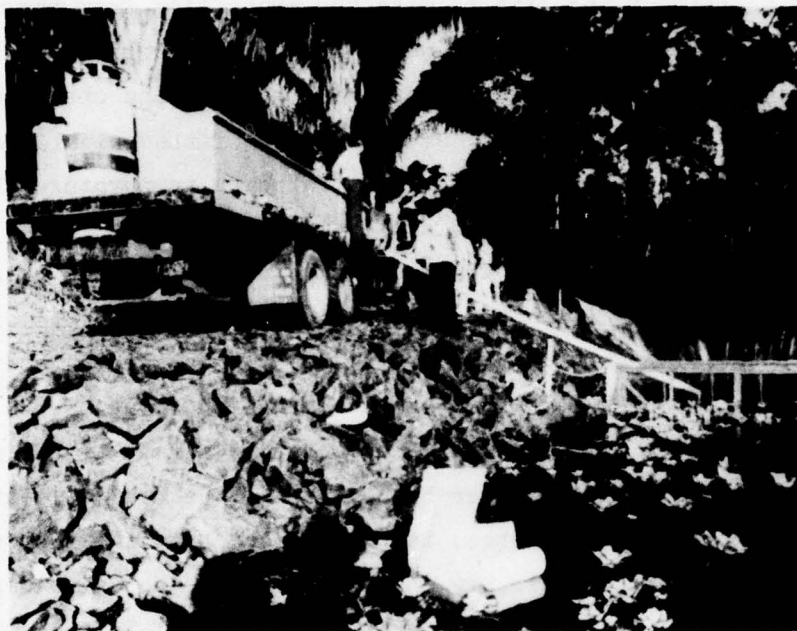
Figure 8. Depositing the third shipment of fish into the grow-out pond

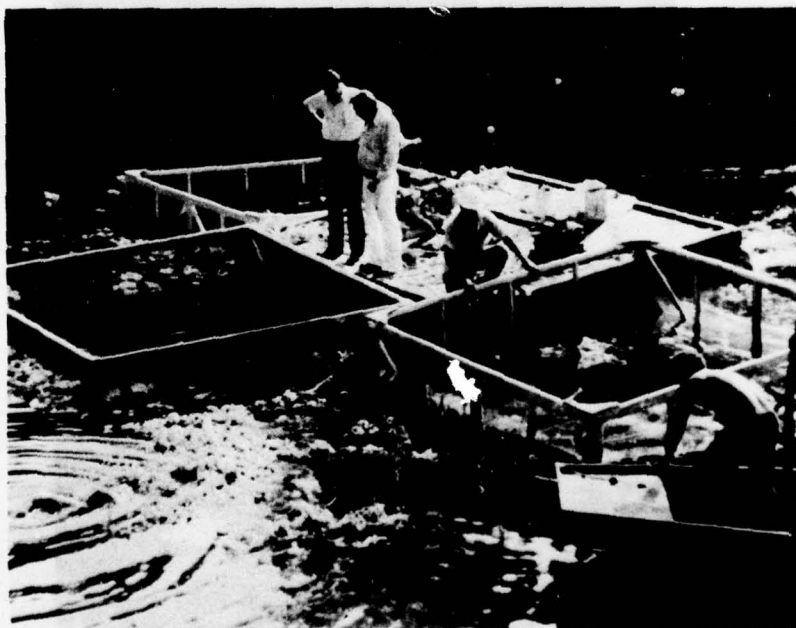
Figure 9. Observation of the fish from the third shipment in the screened enclosure for 45 minutes revealed that they suffered no temperature shock in going from the cold transport water to the warm lake. (If stress had developed, air compressors were standing by to begin aeration under the enclosure to revive the fish.)

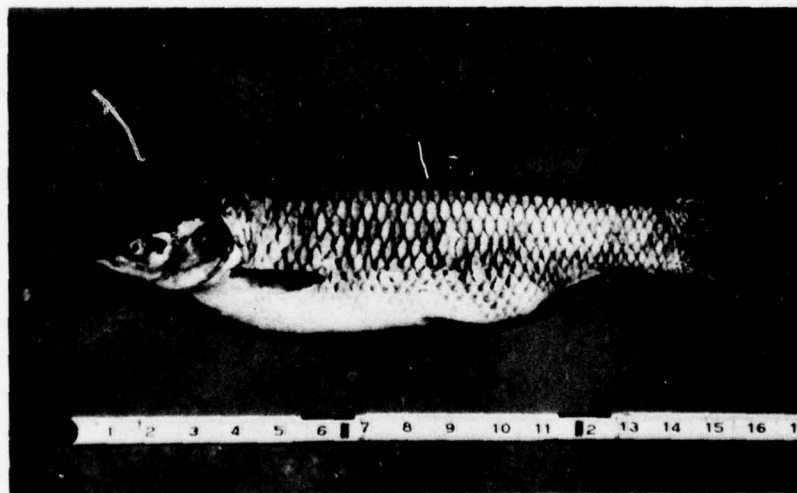
Figure 10. White amur fish from second delivery approximately 4 months after introduction to grow-out pond. Weight, 2 lb; length, 16-1/4 in.

39. In mid-July, large schools of fish were observed swimming along the dike. One of them was successfully caught on 11 July in order to measure its weight and size. It weighed exactly 2 lb and was 16 in. long (Figure 10). At that point, a decision had to be made as to whether or not to release the fish into Gatun Lake or hold them in the grow-out ponds longer. In order to demonstrate their capabilities, it was decided to keep them in the grow-out ponds until they had consumed all the hydrilla.

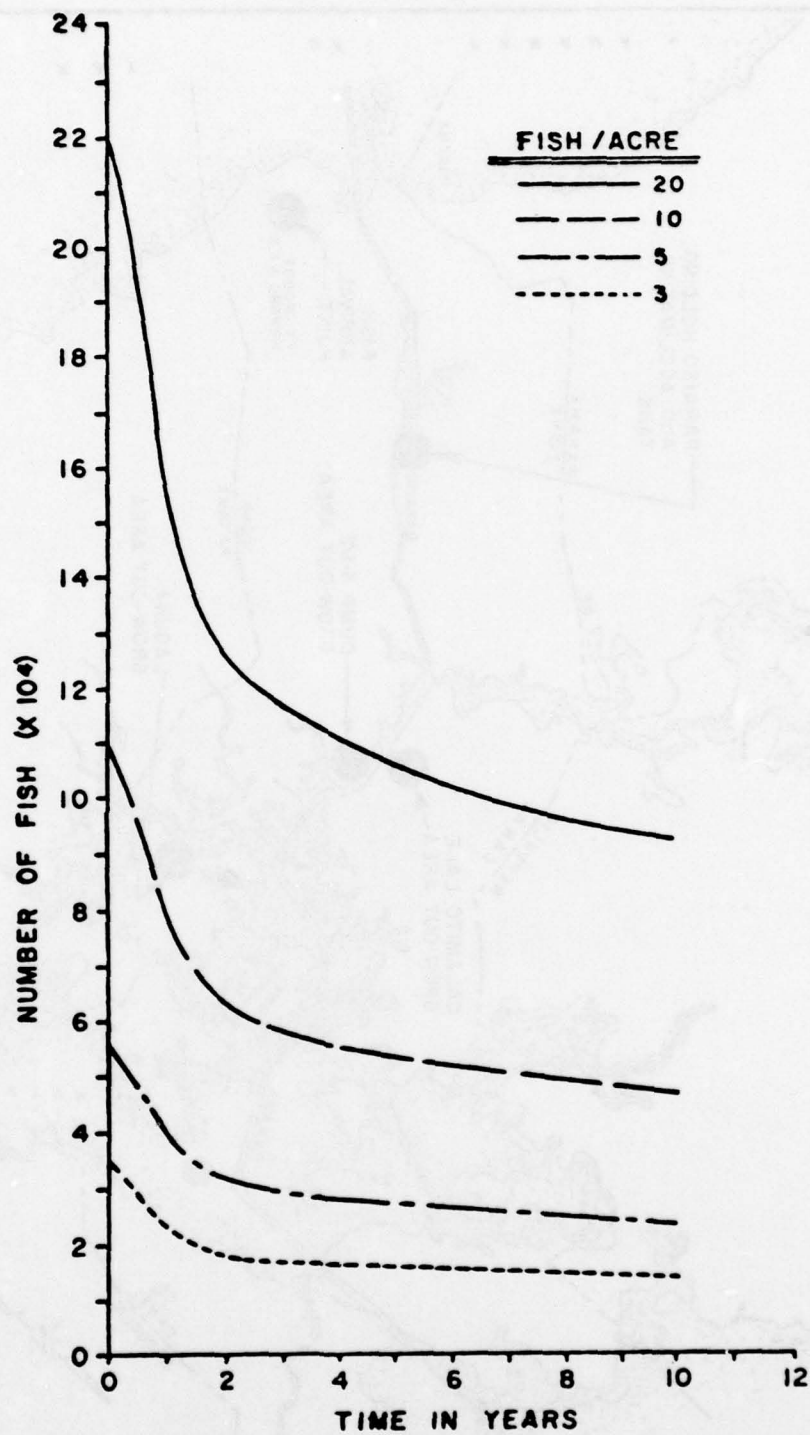
9. The biomass data and the other required parameters were used as input to the model with several different stocking rates for predictions of biomass of hydrilla and growth rate and mortality of the white amur (Plates 3-5).

WHITE AMUR MORTALITY RATE
PREDICTED BY WES COMPUTER MODEL
GATUN LAKE

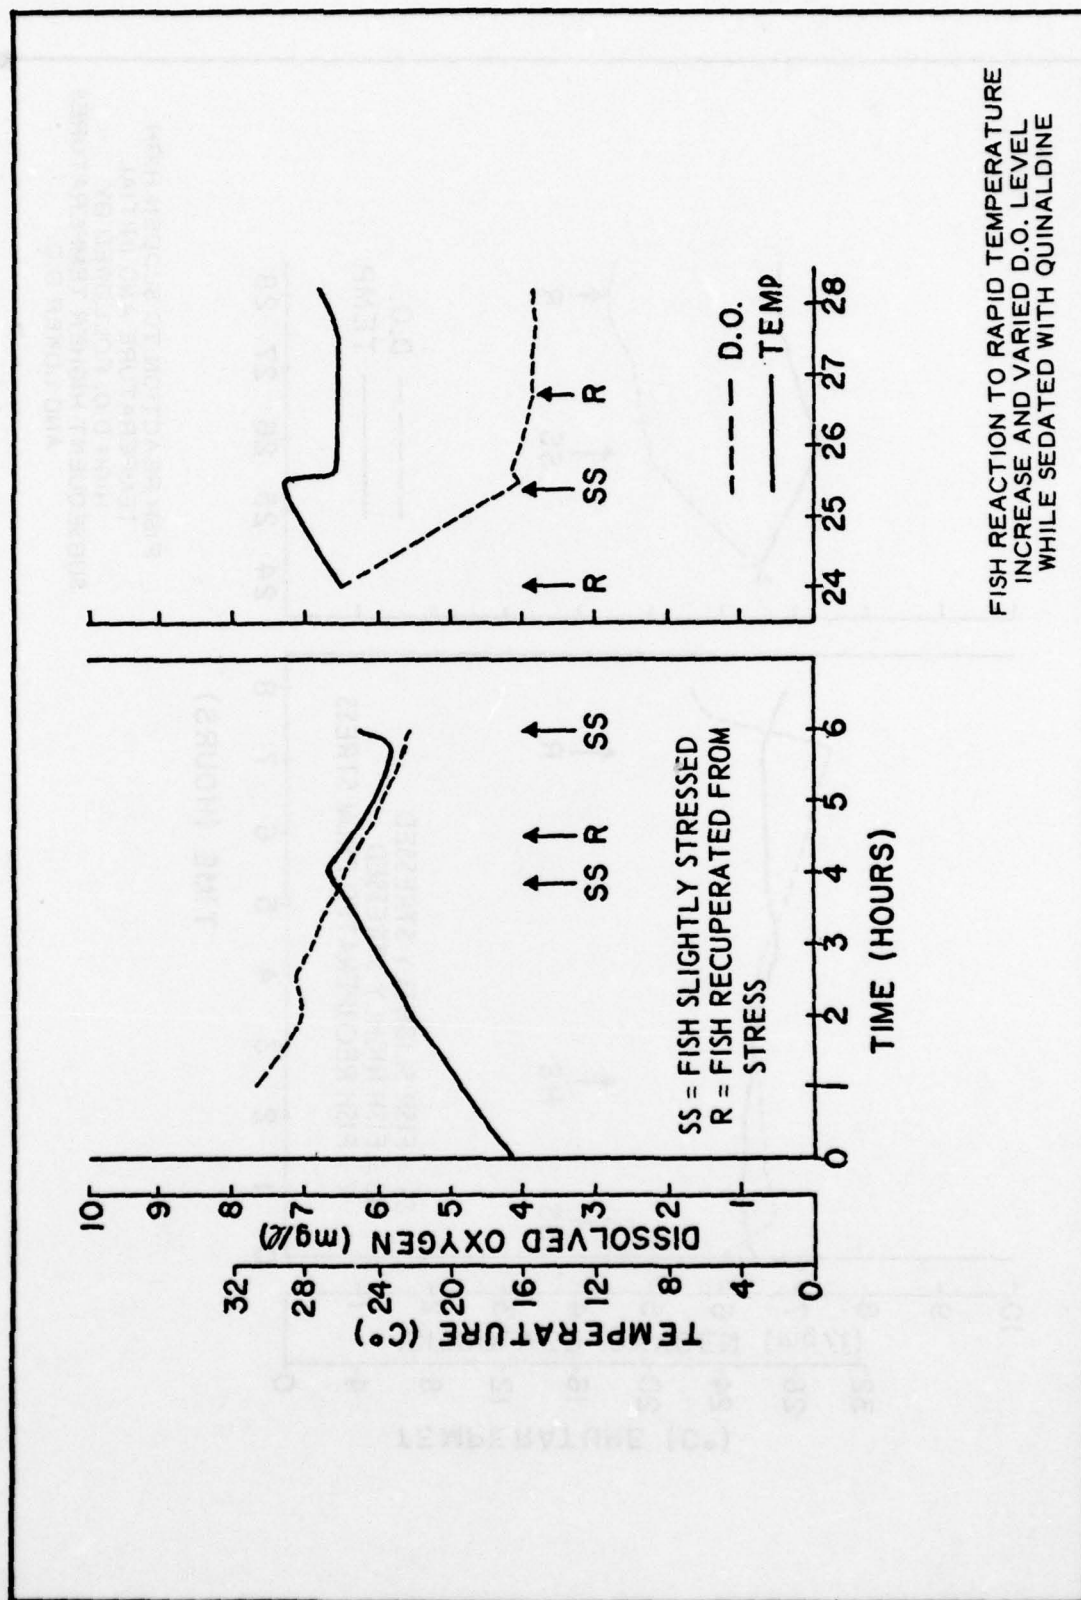
FISH REACTION TO RAPID TEMPERATURE INCREASE AND VARIED D.O. LEVEL WHILE SEDATED WITH QUINALDINE

22. One test was made to determine the effect of a sudden temperature change while the fish were under sedation (quinaldine) maintaining D.O. levels similar to those of the rearing ponds. Reactions are indicated in Plate 8.

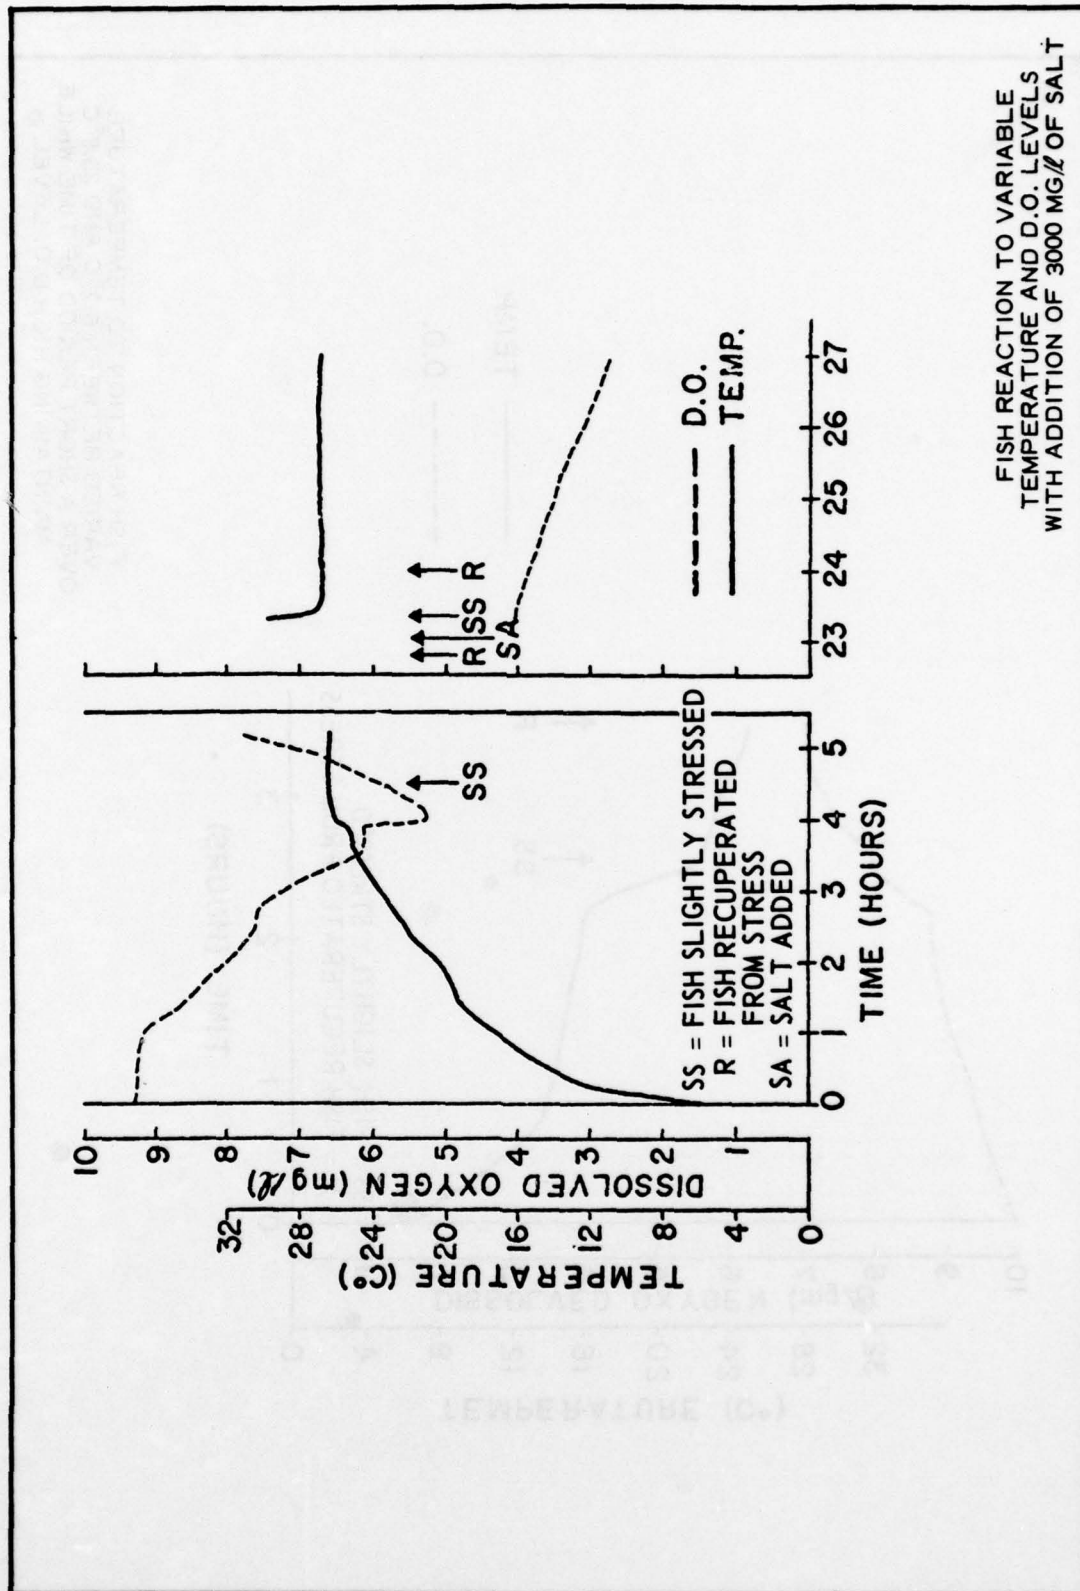
FISH REACTION TO VARIABLE
TEMPERATURE AND D.O. LEVELS
WITH ADDITION OF 3000 MG/L OF SALT

23. Two tests were conducted to determine the effects of salt with variable temperature rates and D.O. levels. Results are shown in Plate 9.

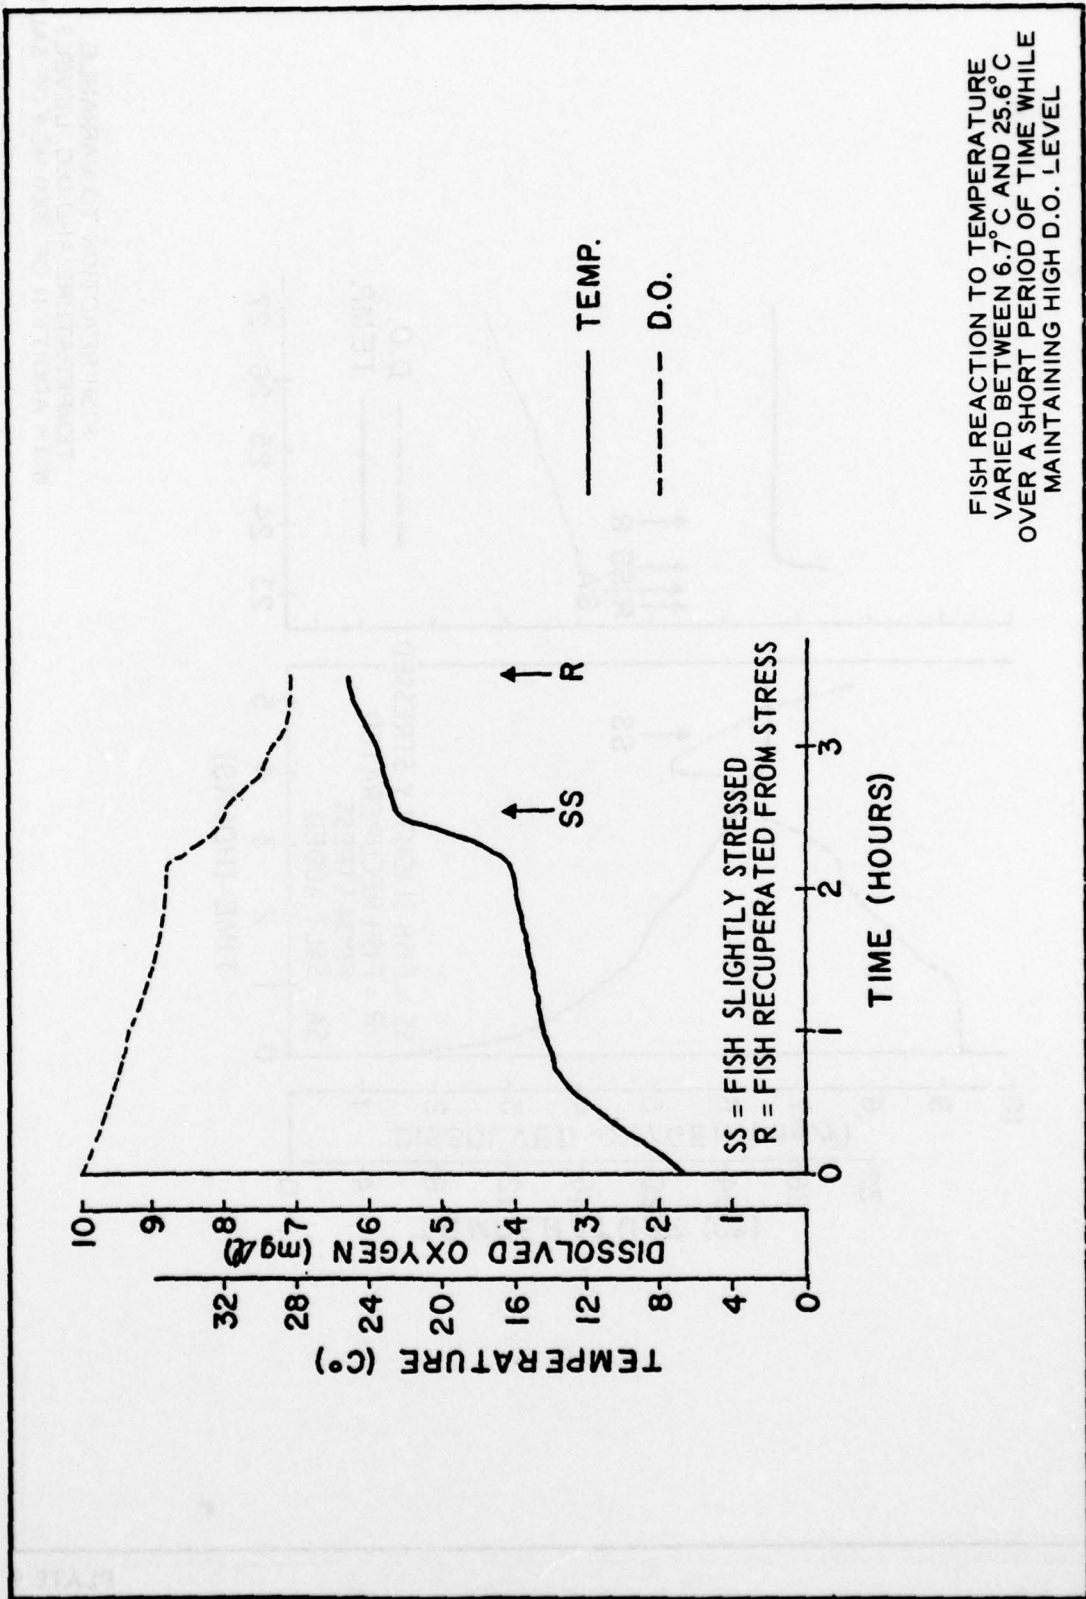
PLATE 10

24. The reactions of the fish to raising the temperature through the entire temperature range while maintaining a high D.O. level were examined. Results are recorded in Plate 10.

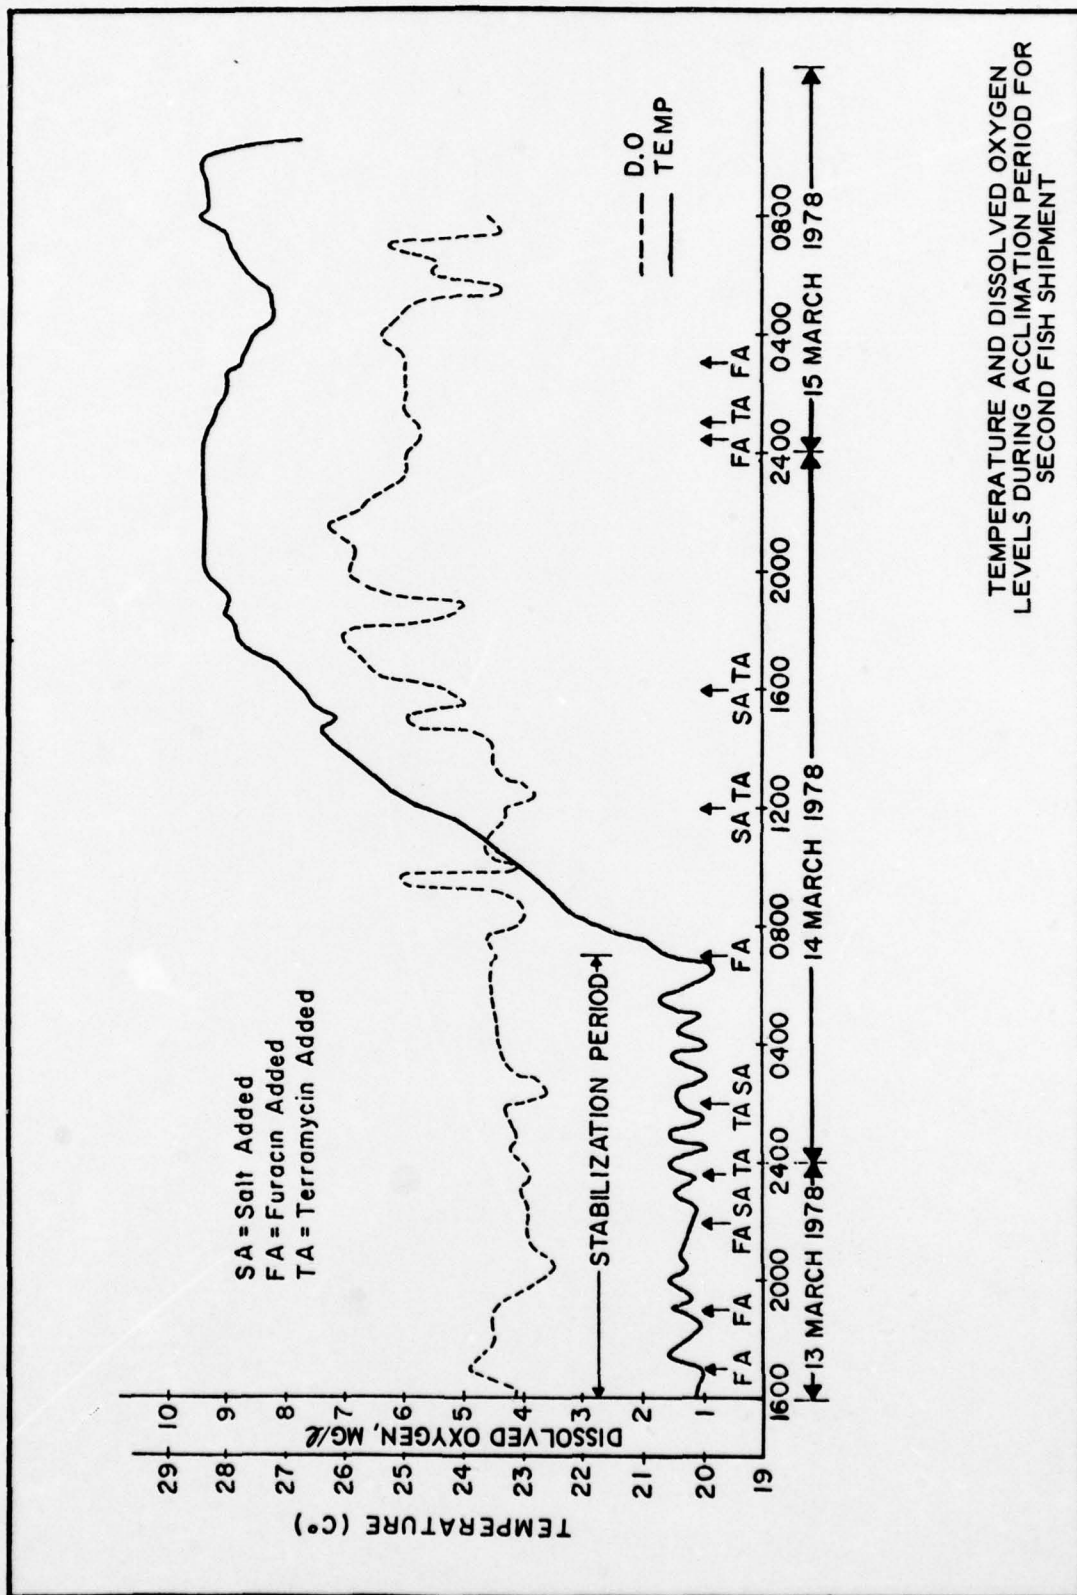
PLATE 13

fish had been moved into the tank by 1100 hours. Acclimation procedures were begun shortly thereafter by increasing the temperature in the tank gradually at a rate of 3°C per hour. At 1600 hours that afternoon, the tank water was 20°C and all fish were doing well. D.O. levels were maintained in the range of 4 to 7 mg/l. Constant monitoring and recording of temperature and D.O. levels were initiated at 1600 hours when a stabilization period of 15 hours at 20 to 21°C and 4 to 6 mg/l D.O. was begun. The temperatures, D.O. concentrations, and remarks for the final acclimation period which began at that time are shown in Plate 13.

TEMPERATURE AND DISSOLVED OXYGEN
LEVELS DURING ACCLIMATION PERIOD FOR
SECOND FISH SHIPMENT
